Application Guide

UTILITY BOILERS - OIL/GAS FIRED

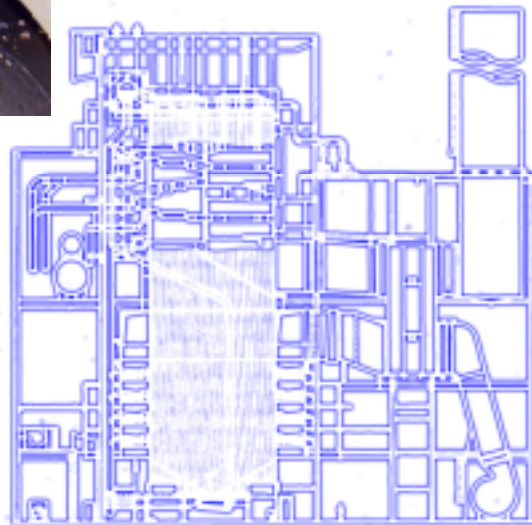
Burner Throats

- Normal Service*
- Plibrico 80 AB
- High Duty Service*
- Plibrico 68S A
- Severe Service*
- Plibrico 85 S Special

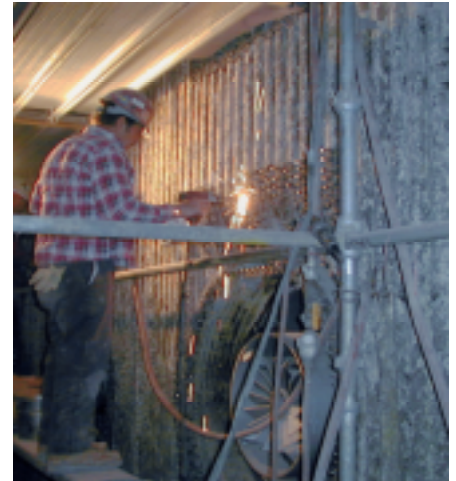
Burner Throats

- (Water Cooled)
- Normal Service*
 - Pligun 3100 Sp
 - High Duty Service*
 - Pligun HyMOR 8
 - Severe Service*
 - Plibrico 85 S Special
